Use of Surveillance Video in the Reconstruction of a Maritime Collision

Edward V. Fritsch, P.E. - Senior Staff Mechanical Engineer, ATA Associates, Inc.

Summary

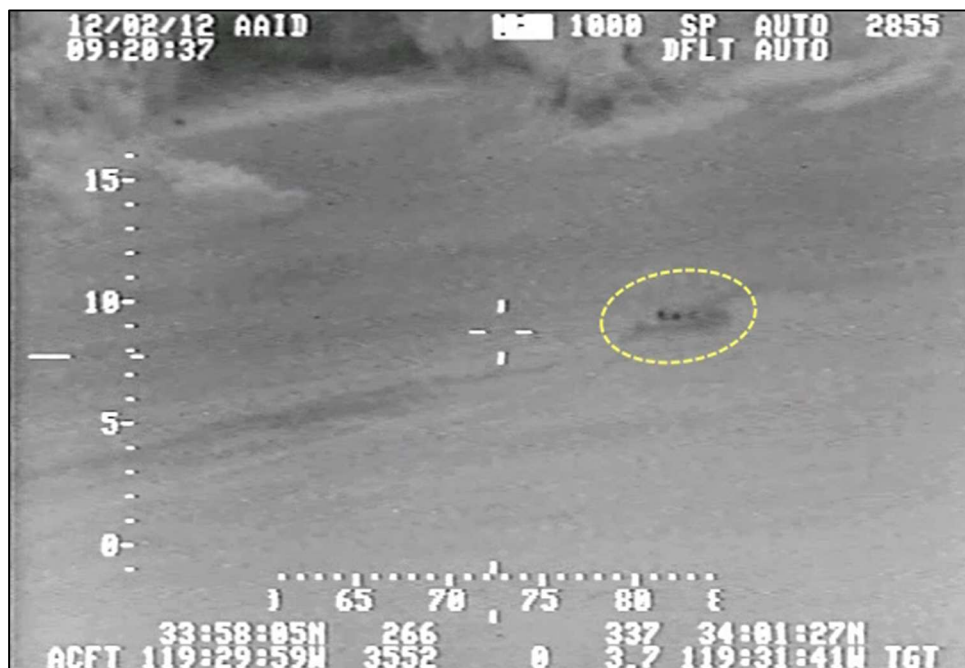
Figure 1 – FLIR video frame showing the collision in the dashed oval (*author's annotation*)

The subject incident began when the *panga* was observed lingering close to Santa Cruz Island by the crew of a USCG C-130 aircraft on a routine nighttime coastal patrol. An 18-foot RHIB with a crew of four was launched from the USCG Cutter *Halibut* to investigate. Time-stamped video recorded by the C-130's forward looking infrared (FLIR) observation system showed that as the RHIB approached the loitering *panga*, the 30-foot vessel abruptly accelerated and turned toward the smaller RHIB, colliding with it and overrunning it at 1:20:37 AM Pacific Standard Time. Figure 1 is a frame grab from the video showing the collision. GPS position data, displayed with the FLIR image as seen in Figure 1, will be explained after this synopsis of the incident concludes.

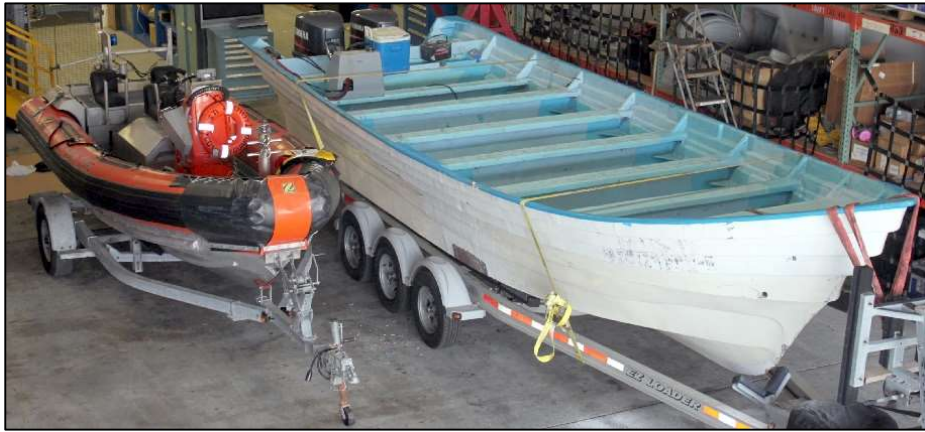
Figure 2 shows the two vessels which collided. The RHIB was a 3,640-lb. Zodiac Hurricane powered by a 200-horsepower inboard engine with a jet drive. The panga had no markings to identify either its maker or owner. The panga design, attributable to a 1970s joint effort by Yamaha and the World Bank to develop a practical boat for subsistence fishermen, is commonly seen in the developing world. This particular fiberglass vessel, fitted with two 200-horsepower outboard motors, weighed 4,550 lbs. Tests by ATA showed that it was capable of accelerating forward at 9 ft/sec^2 to a top speed of about 41 knots, with a minimum turning radius of about 46 feet.

Figure 2 – The RHIB (at left) and the panga

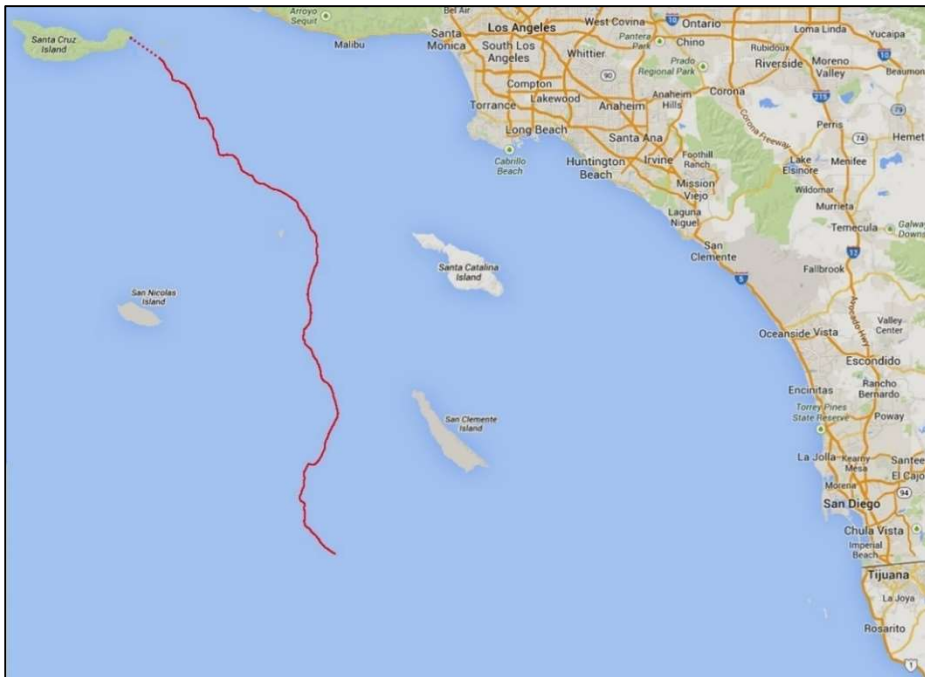
After the collision, the RHIB and its crew were recovered by the *Halibut*. The panga fled south, tracked by the C-130, which eventually handed over the chase to a USCG helicopter. A lengthy pursuit, mapped by the red line in Figure 3, ended when the panga was intercepted and its operator and crewman were apprehended by the crew of a USCG response boat dispatched from San Diego.

Figure 3 – The path of the panga's flight south from the scene of the collision

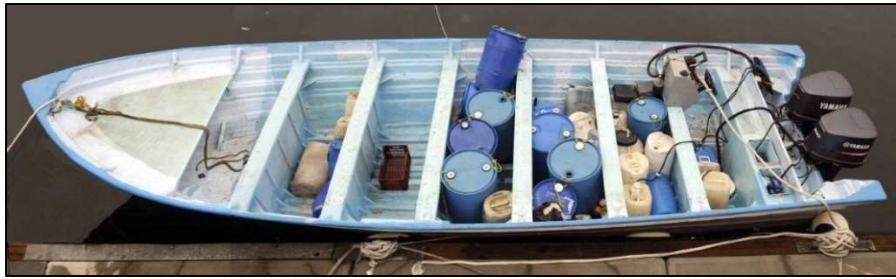
No contraband was found on the panga when it was seized. Instead, it was found to be carrying over 2,400 lbs. of gasoline (about 390 gallons) in assorted barrels and jugs as shown in Figure 4.

Figure 4 – The seized panga with its load of barrels and jugs filled with gasoline

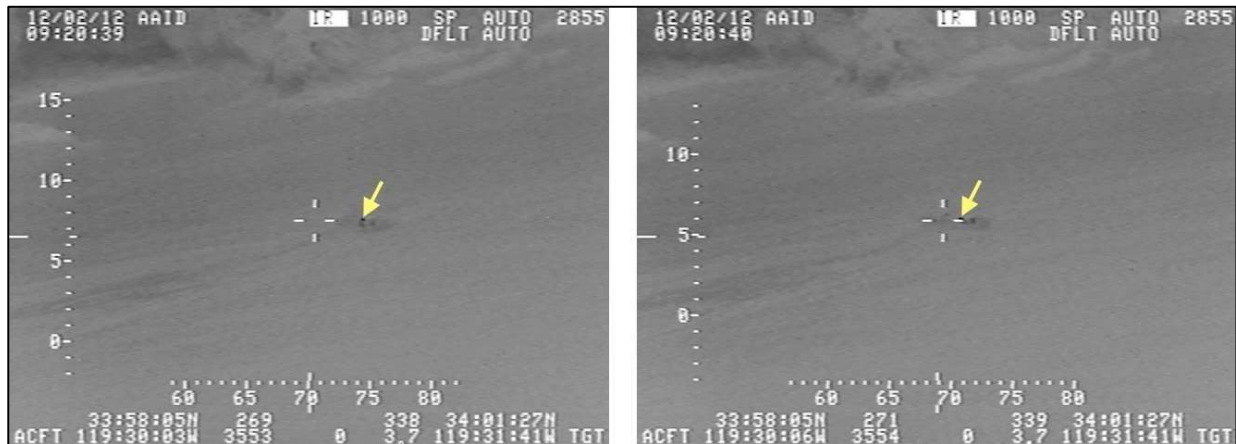
As the panga moved toward and through the collision, the RHIB's crew fired shots at the panga in self-defense. Muzzle flashes from those shots appear in the FLIR video at 9:20:36, 9:20:37, 9:20:39 and 9:20:40 GMT. In Figure 5, frame grabs from the FLIR video, presented side-by-side, document the last two of those flashes. The flashes, which are more recognizable in the moving

Figure 5 – FLIR video frames showing separate muzzle flashes marked by the arrows (*author's annotations*)

video image than they are in the static frame grabs, appear as black blotches. That conforms with the spectral conventions of the FLIR night-vision system where the brightness of an object, as it appears in the image, is inversely proportional to that object's temperature – cooler objects appearing lighter and warmer objects darker.

In the video, the date and time appear at the upper left of the frame and the position of the aircraft appears at the lower left. For example, the left frame in Figure 5 shows that, at 9:20:39 GMT, the aircraft was at latitude $33^{\circ} 58' 5''$ N, longitude $119^{\circ} 30' 3''$ W, on a compass heading of 269° , at an altitude of 3,553 ft. One second later, at 9:20:40 GMT, the right frame shows that the aircraft's longitude had increased slightly, indicating westward travel which is consistent the aircraft's average heading of 270° .

At the bottom right of each frame, a calculated latitude and longitude are displayed for the point on the Earth's surface that corresponds to the target cross at the middle of the frame. Also shown at lower right of each frame are the camera's pointing direction (339°) and the distance through the air from the camera to the point on the Earth's surface overlaid by the cross (3.7 nautical miles).

In both frames of Figure 5, the target cross is identified as being at latitude $34^{\circ} 1' 27''$ N, and longitude $119^{\circ} 31' 41''$ W. That geographic location was chosen by the Coast Guard as the spot to start a post-incident search for a personal defense weapon that was lost by a member of the RHIB's crew when he was knocked overboard during the subject incident. The initial attempt to find the weapon there was unsuccessful, and it was not until the search area was widened considerably, in January 2013, that the weapon was found by an FBI diver at $34^{\circ} 1' 31.57''$ N, $119^{\circ} 31' 42.47''$ W in water 25 ft. deep, almost 500 ft. from the location suggested by the video.

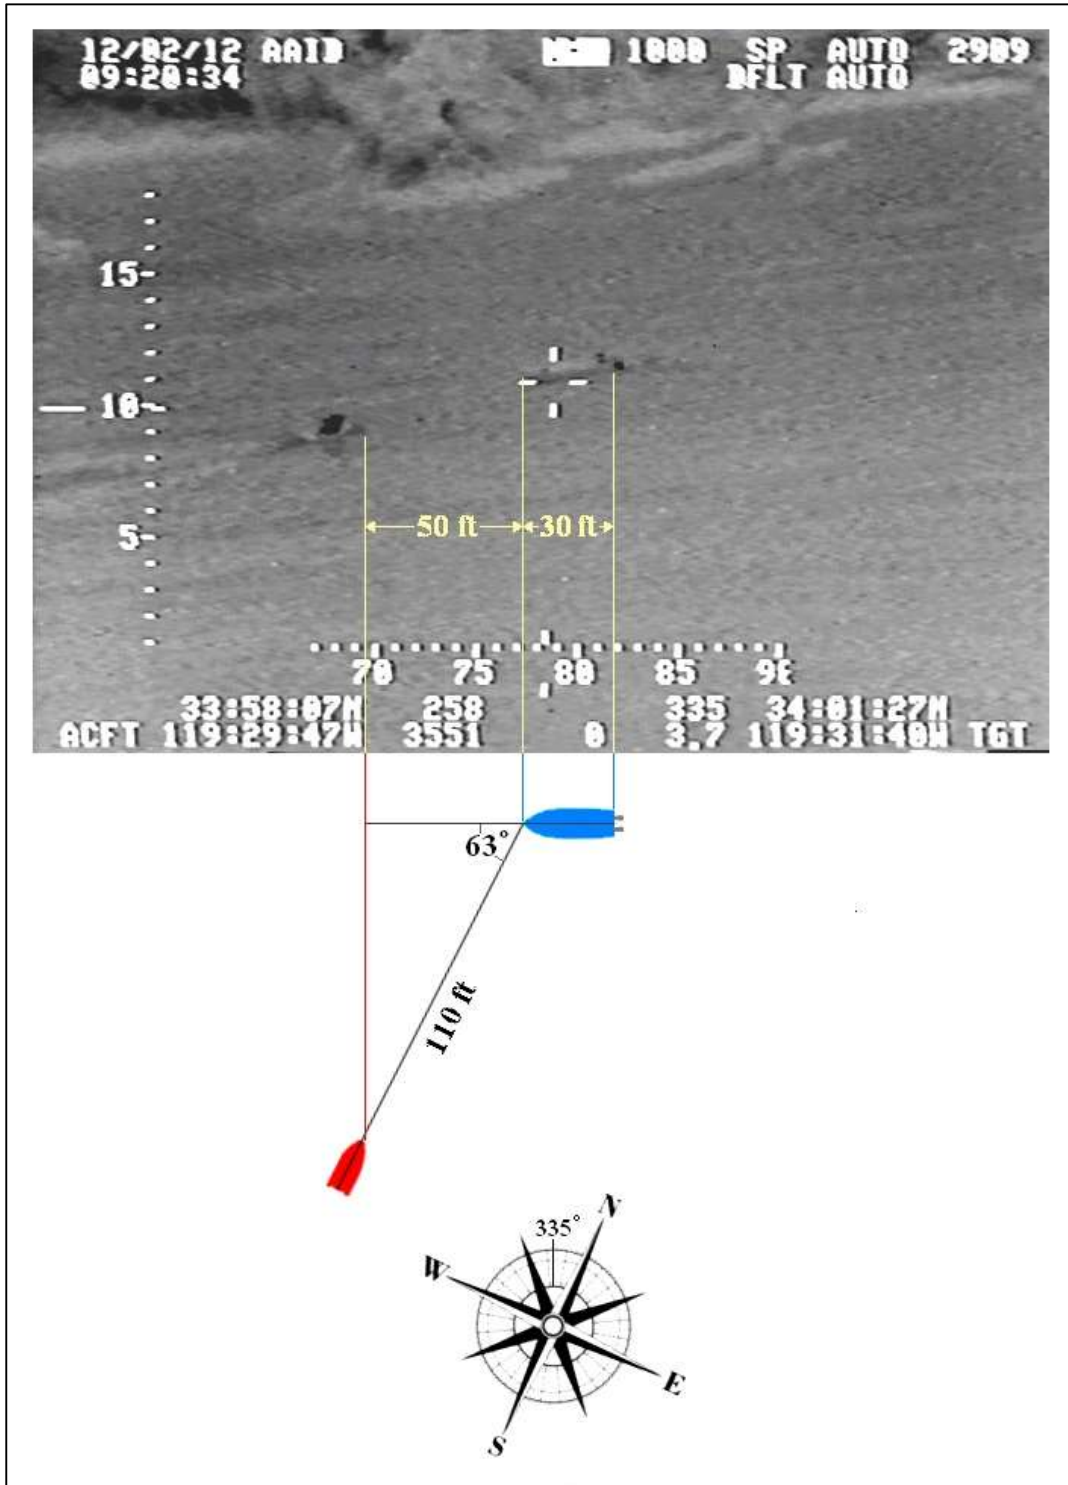
The frame grab at the top of Figure 8 shows the scene, just 3 seconds before the collision, when the video record shows that the panga began its abrupt forward acceleration and turn to port. The view shows that the panga is nearly perpendicular to the camera's line of sight, allowing the boat's 30 ft. length to serve as a basis for estimating other distances in the diagram below the screen grab.

Figure 8 - A frame grab and overhead diagram of the scene, 3 seconds before the collision

As indicated by the compass rose, the diagram at the bottom of Figure 8 has been rotated to be aligned with the camera's pointing direction (335°) indicated in the frame grab at the top of the figure. Relative to that compass reference, the panga is seen to have been pointed toward the west-southwest. The direction of travel of the RHIB shown in the diagram agrees with the aircraft radio operator's affidavit statement that the RHIB was approaching the panga from due south of the panga's position shortly before the collision. The 110 ft. separation distance shown in the diagram also agrees reasonably well with the radio operator's affidavit testimony that the RHIB was about 40 meters (131 ft.) from the panga when the panga began to move as if abruptly throttled up.

In the case of the subject collision, it is the author's conclusion, based upon the FLIR video and other evidence, that the panga operator's acceleration and turn toward the approaching RHIB was a deliberate, aggressive use of his vessel against the smaller RHIB which resulted in the death of Terrell Horne. It is the author's conclusion that, despite the fact that panga was partially boxed-in by its close proximity to Santa Cruz Island, more probably than not in a failed attempt to avoid detection, there was still ample deep water ahead of the panga that would have provided the operator with an open avenue for escape from the approaching RHIB if the panga operator had chosen simply to flee.
